Refractory Inspection, Advice and Third Party Q.A

## **NEW DEVELOPMENTS IN FCCU ANCHORING SYSTEMS** **FOR** **THIN ABRASION RESISTANT LININGS**

**COMPILED BY: DARROL BIGGS**  
**OCTOBER 2006**

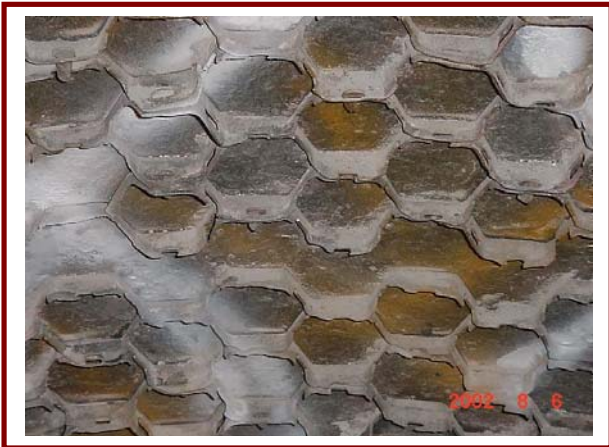
**Fig. 01** Hexmesh on Cyclone Roof after removal of refractory

Extensive unplanned repairs to 12 Regenerator Cyclones resulted in an opportunity to use the single point anchor system with ACTCHEM. The radical approach was adopted due to major time constraints, lack of experienced boiler makers for fitting hexmesh as well as insufficient hexmesh, s-bars and punched corner tabs. To further save on repair time the refractory was chipped out and the existing worn hexmesh was left in-situ. Single point Vee anchors, 6mm diameter, 25mm long, 310 s/s, were welded into each hex cell, see fig 01&2.

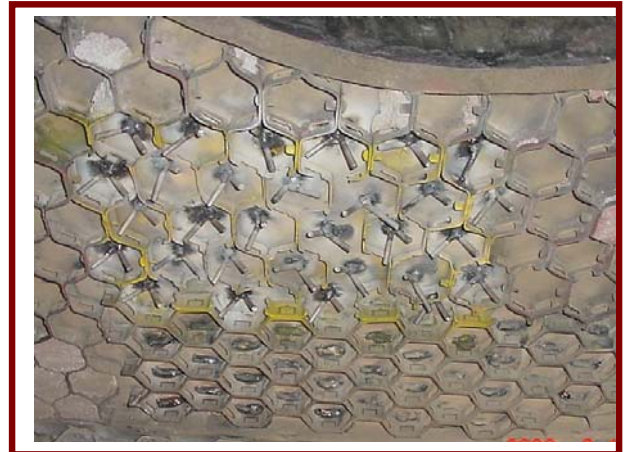
**Fig. 02 Before** - Hexmesh with addition of single point Vee anchors on Cyclone Roof.

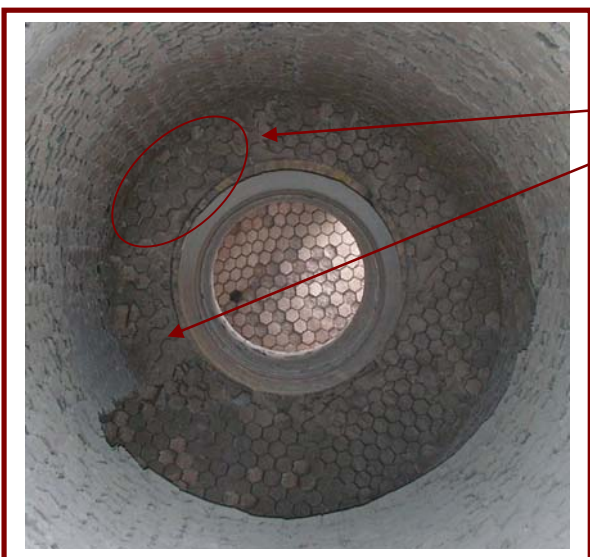
**Fig.03 After** - ACTCHEM still intact on Vee anchors within hex cells after 4 years service.

Although the repairs were undertaken as temporary while the client ordered new Cyclones, CHB were confident that we would achieve a sound homogeneous lining with sufficient anchorage to attain the maximum run duration. The repairs out performed all expectations and lasted the require 4 year cycle to the next shutdown. This saved the refinery millions of Dollars by avoiding un-necessary down time for further patch repairs.

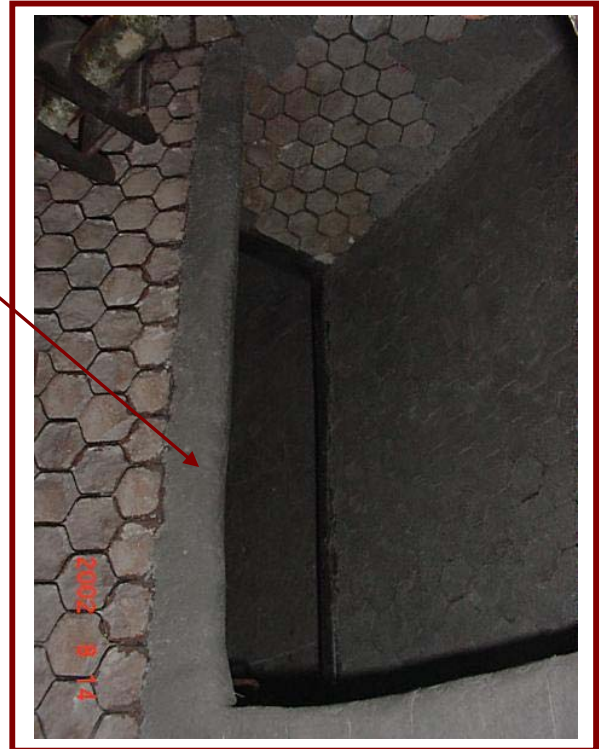
**Fig. 04** Corner repair area to cyclone inlet after refractory application onto single point anchors

**CYCLONES WERE INSPECTED AFTER 4 YEARS SERVICE WITH NO SIGNS OF WEAR OR ANCHOR FAILURE.**

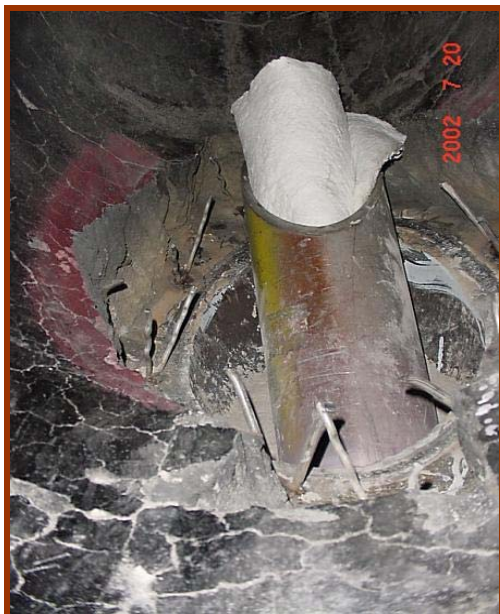
**Fig. 05**

In a modification to an existing steam nozzle in the J-bend of a Riser line, the client opted for the repair to the traditional 100mm thick vibro-cast lining with ACTCHEM 75 (hand pack) with the addition of 3%, 310 s/s fibre. Technically the ACTCHEM 75 had superior properties to the surrounding vibro-cast lining and together with the ease of installing a plasticized material CHB was confident of a sound repair in an otherwise high risk area. The ACTCHEM 75 was hand packed onto 5.5 mm diameter, 304 s/s, wavy Vee, anchors, 100mm length.

Additional anchors were welded in after this photo at the lip of the nozzle inlet. A 2mm ceramic fibre paper was wrapped around the nozzle before hand packing the ACTCHEM 75 with steel fibre around the nozzle.

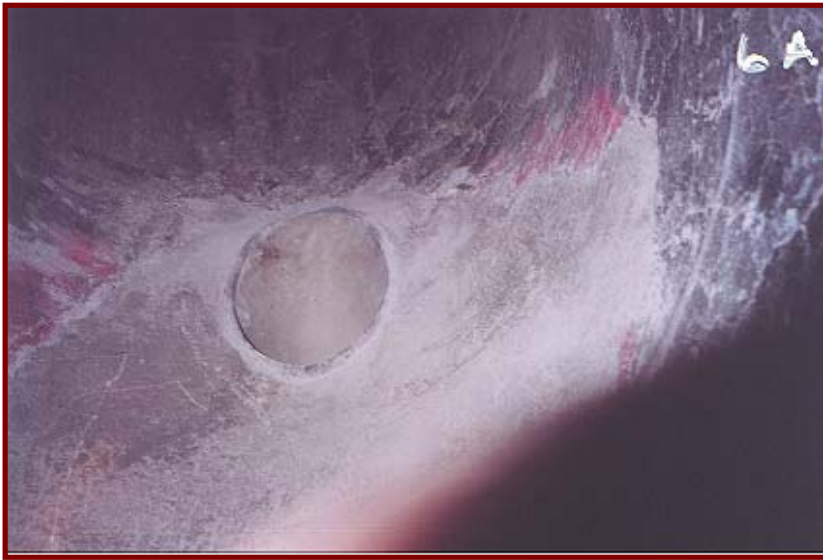
**Fig. 06  
Post Dry-Out Photograph**

**Repair has been in service for 8 years with no signs of abrasion or spalling.**

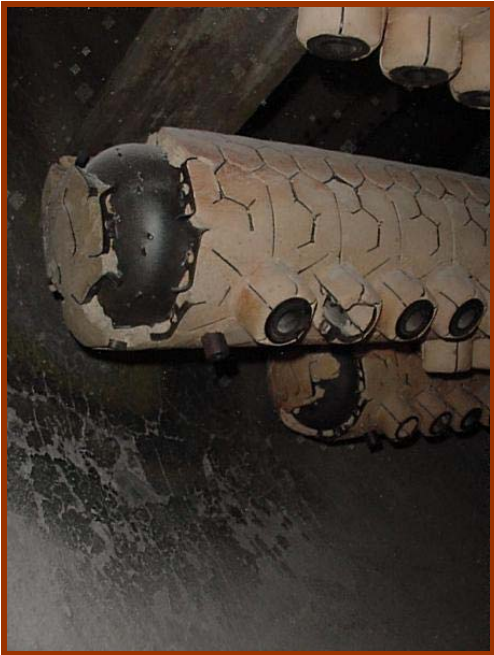
**Fig. 07 - S-bar weld failure on Air Grid Arms**

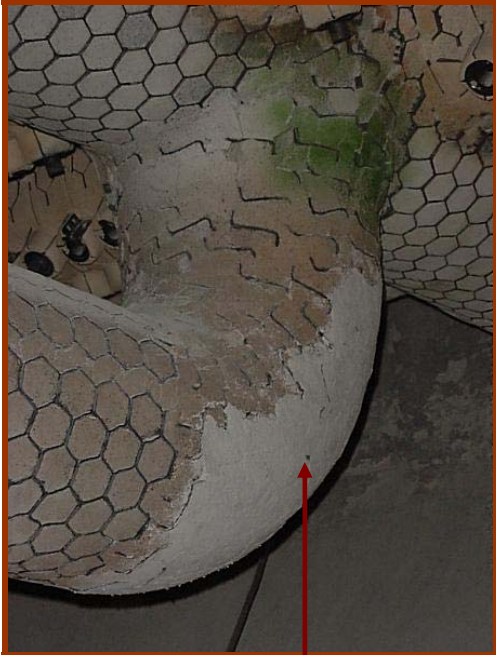
**Fig. 08 ACTCHEM 75 + 3% s/s fibre on Air Grid Elbow**

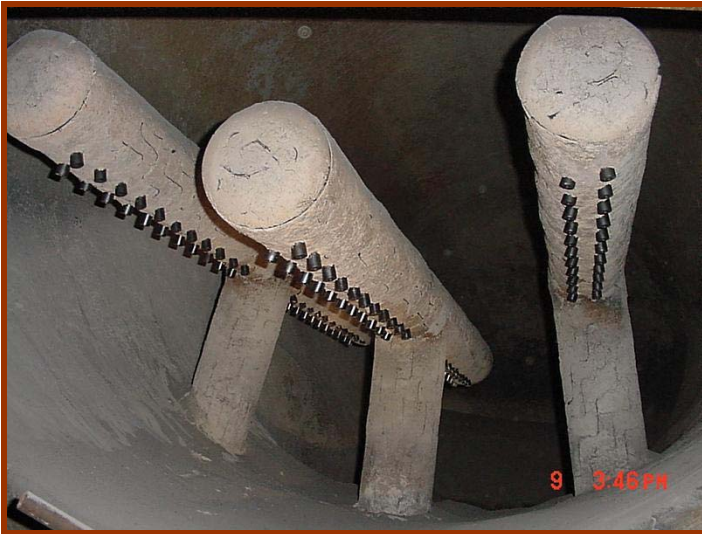
**Fig. 09**

ACTCHEM 45 + 3% s/s fibre on Cat Cooler Air Grid. Single point anchors welded on ends as well as between existing s-bar anchors.

**Inspected after 8 years service:** No signs of abrasion, cracking or spalling. No repairs have been necessary.

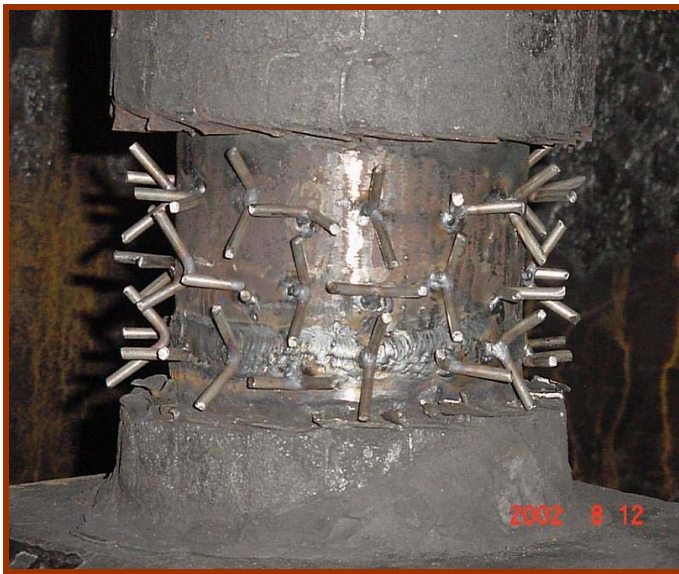
Unplanned modifications to Reactor Trickle Valves resulted in repairs to the abrasion resistant refractory on the diplegs. Actchem 75 was hand packed with 3%, 310 s/s fibre on to single point, 25 mm, V anchors.

**Fig.10**  
**View of Vee Anchors before installation**

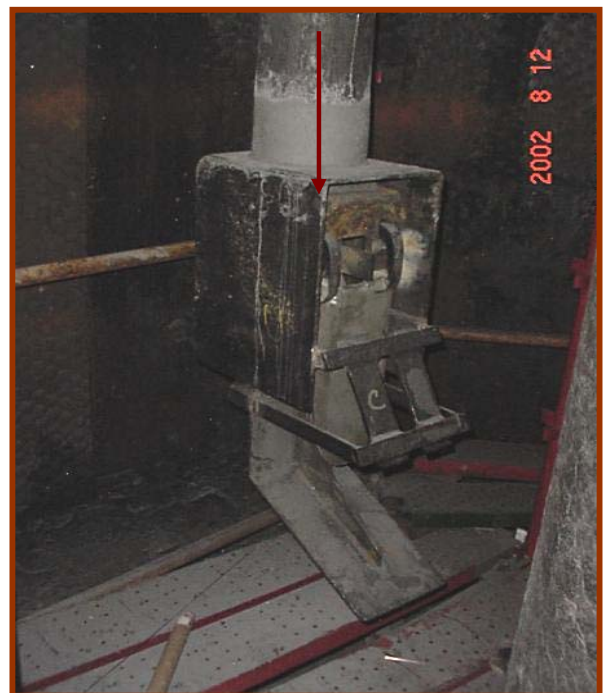
**Fig. 11 Completed repair area**

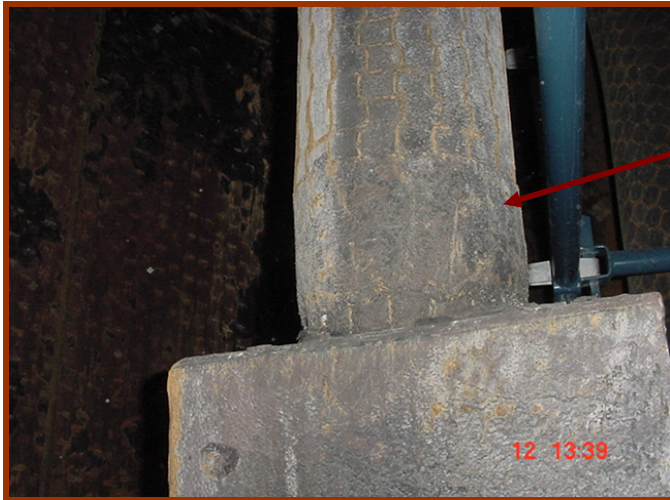
**Fig. 12**  
Dip Leg repairs after being in service for 5 years. Sound lining, no cracking or spalling.

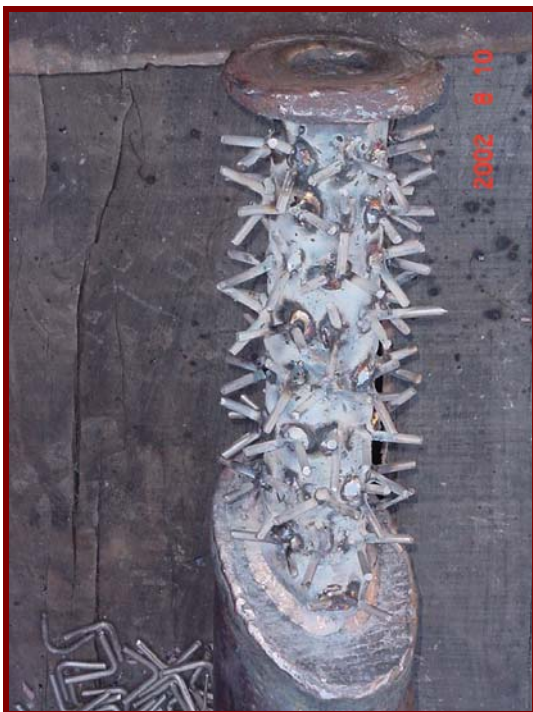
Due to the small diameter and lack of S-bars, single point, 25mm, Vee anchors were hand welded before hand packing Actchem 75 with 3%, 310 s/s fibre.

**Fig. 13 – Nozzle with Vee Anchors**

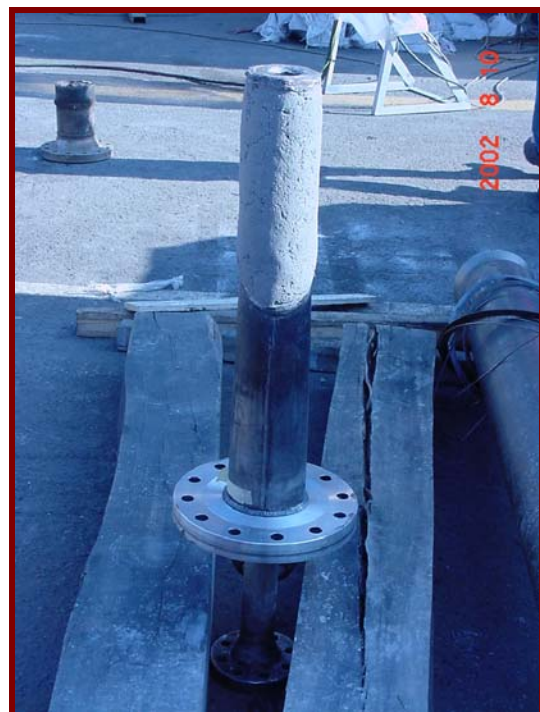
**Fig. 14 - Complete with ACTCHEM 75**

**REPAIR LASTED THE REQUIRE 4 YEAR CYCLE**

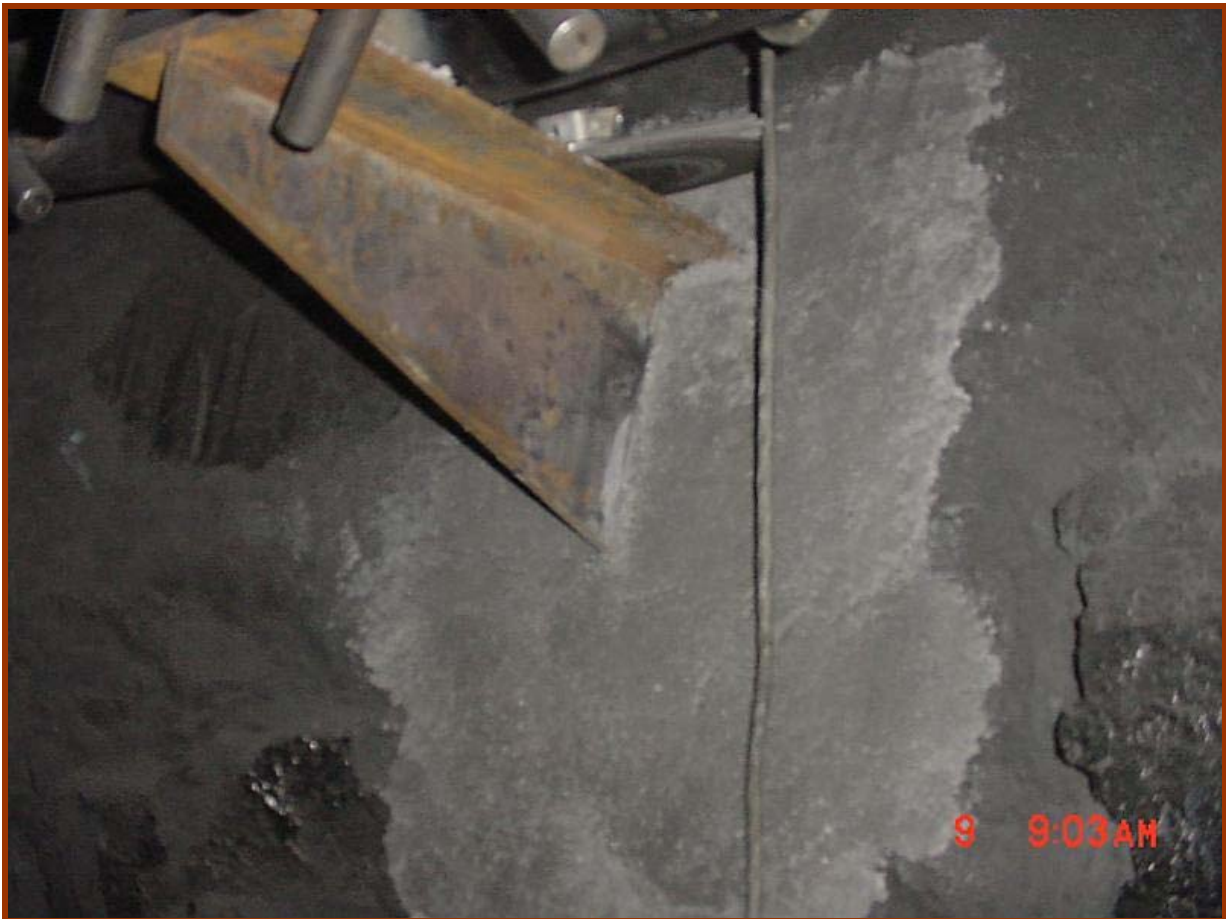
The refractory was broken out around the support plate. New anchors 85mm, 310 s/s were welded in at approx.100mm centres. Two layers of 2mm ceramic paper were glued to the shell to help reduce heat loss as the ACTCHEM 75 had a slightly higher density than the existing vibrocast material. ACTCHEM was mixed with addition of 3% s/s fibre and hand packed around the support to 100mm thickness.

**Inspected after 5 years service:** No signs of abrasion, cracking or spalling. No repairs necessary.

**Fig. 14** – ACTCHEM (grey material) packed onto single point anchors
